108-40-10550 CORRECTION

Water body name: Survey date: 6/29/2013 Water body number: 108-40-10550 Species & Lifestage: COp, Pp

Watershed: Ohmer Creek-Frontal Sumner Strait

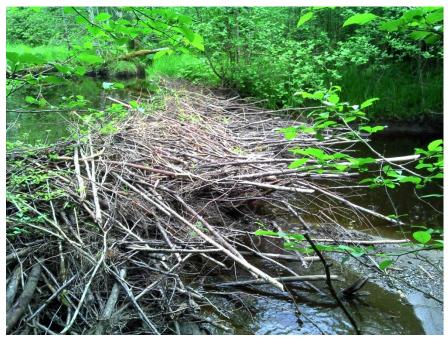
Figure 1.—Beaver dam on 108-40-10550.

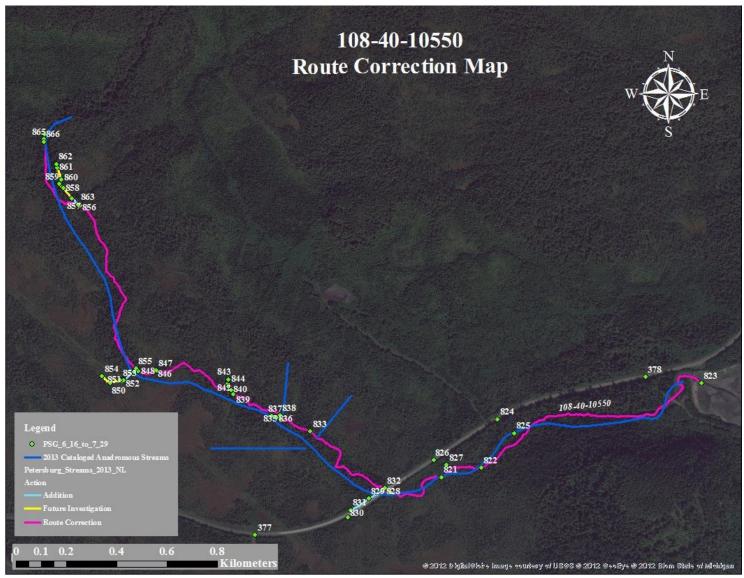
Findings: The route of this creek differs from the current route in the AWC. We ended our

survey at a 4' drop with a dry section above.

Figure 3.–108-40-10550 route correction map.

Recommendations: Correct the route for 108-40-10550 in the AWC.
